**Bioventing Pilot Test Work Plan for
Areas H and K, and Site 2
Hickam AFB, Hawaii**

**Draft Interim Pilot Test Results Report for
Areas H and K, and Site 2
Hickam AFB, Hawaii**

Engineering-Science, Inc.

August 1993

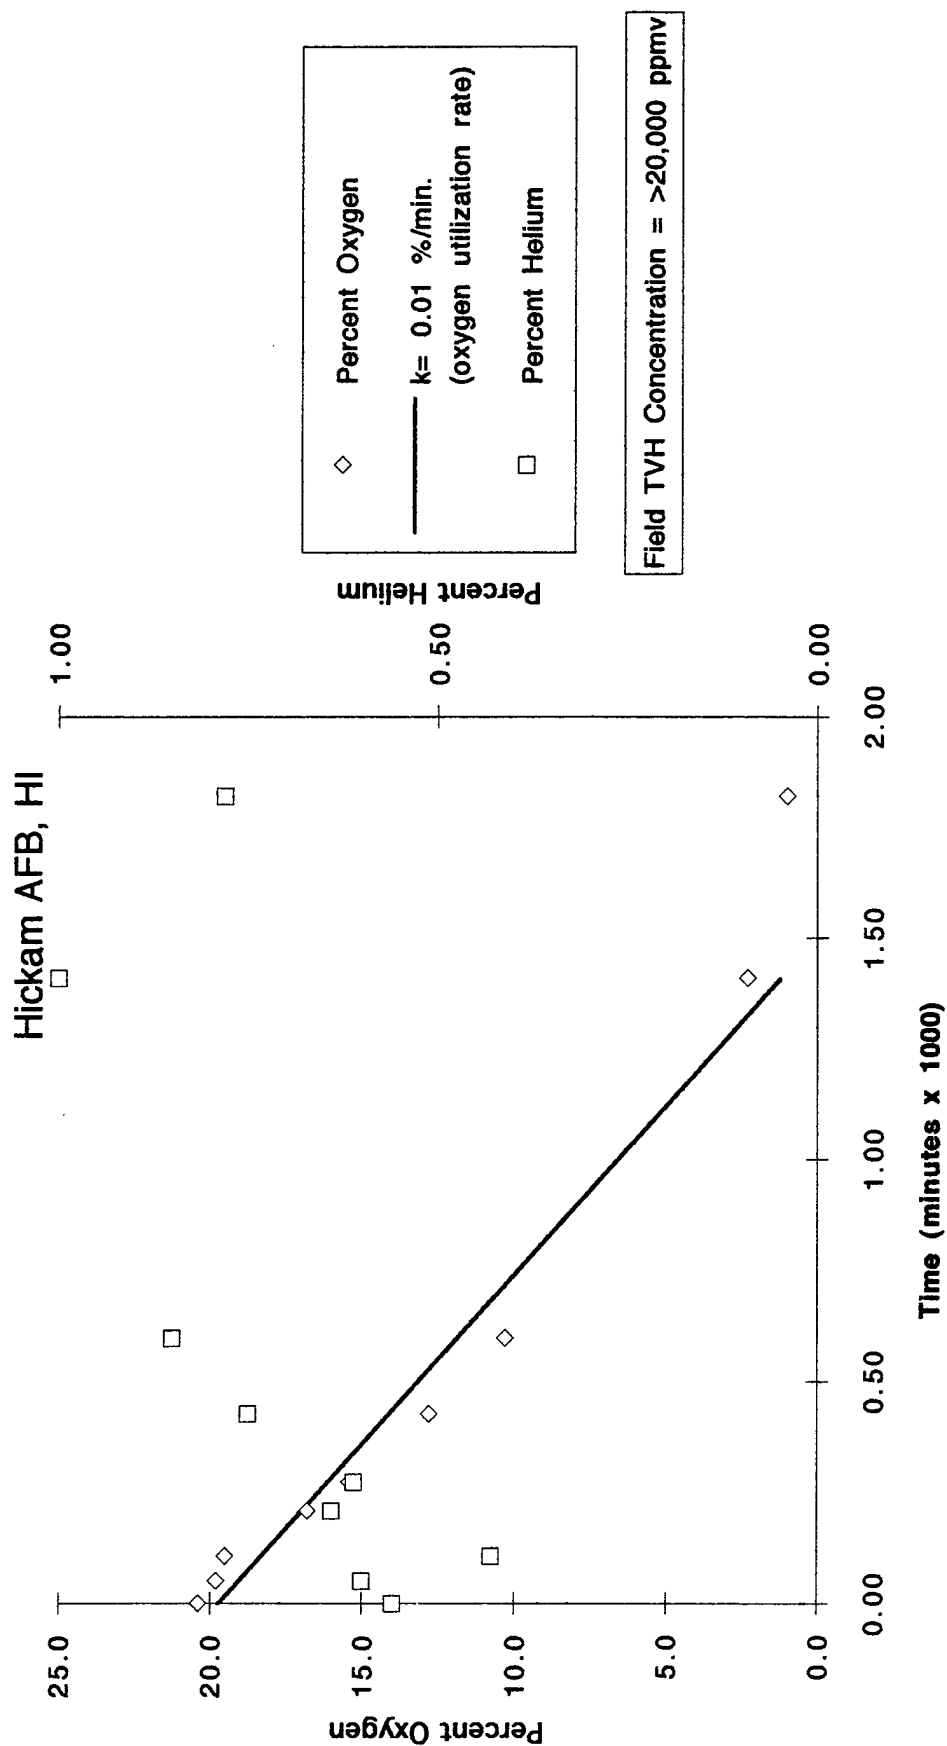
Figure 2.8
Respiration Test
Oxygen and Helium Concentrations
Area K
MPB
Hickam AFB, HI

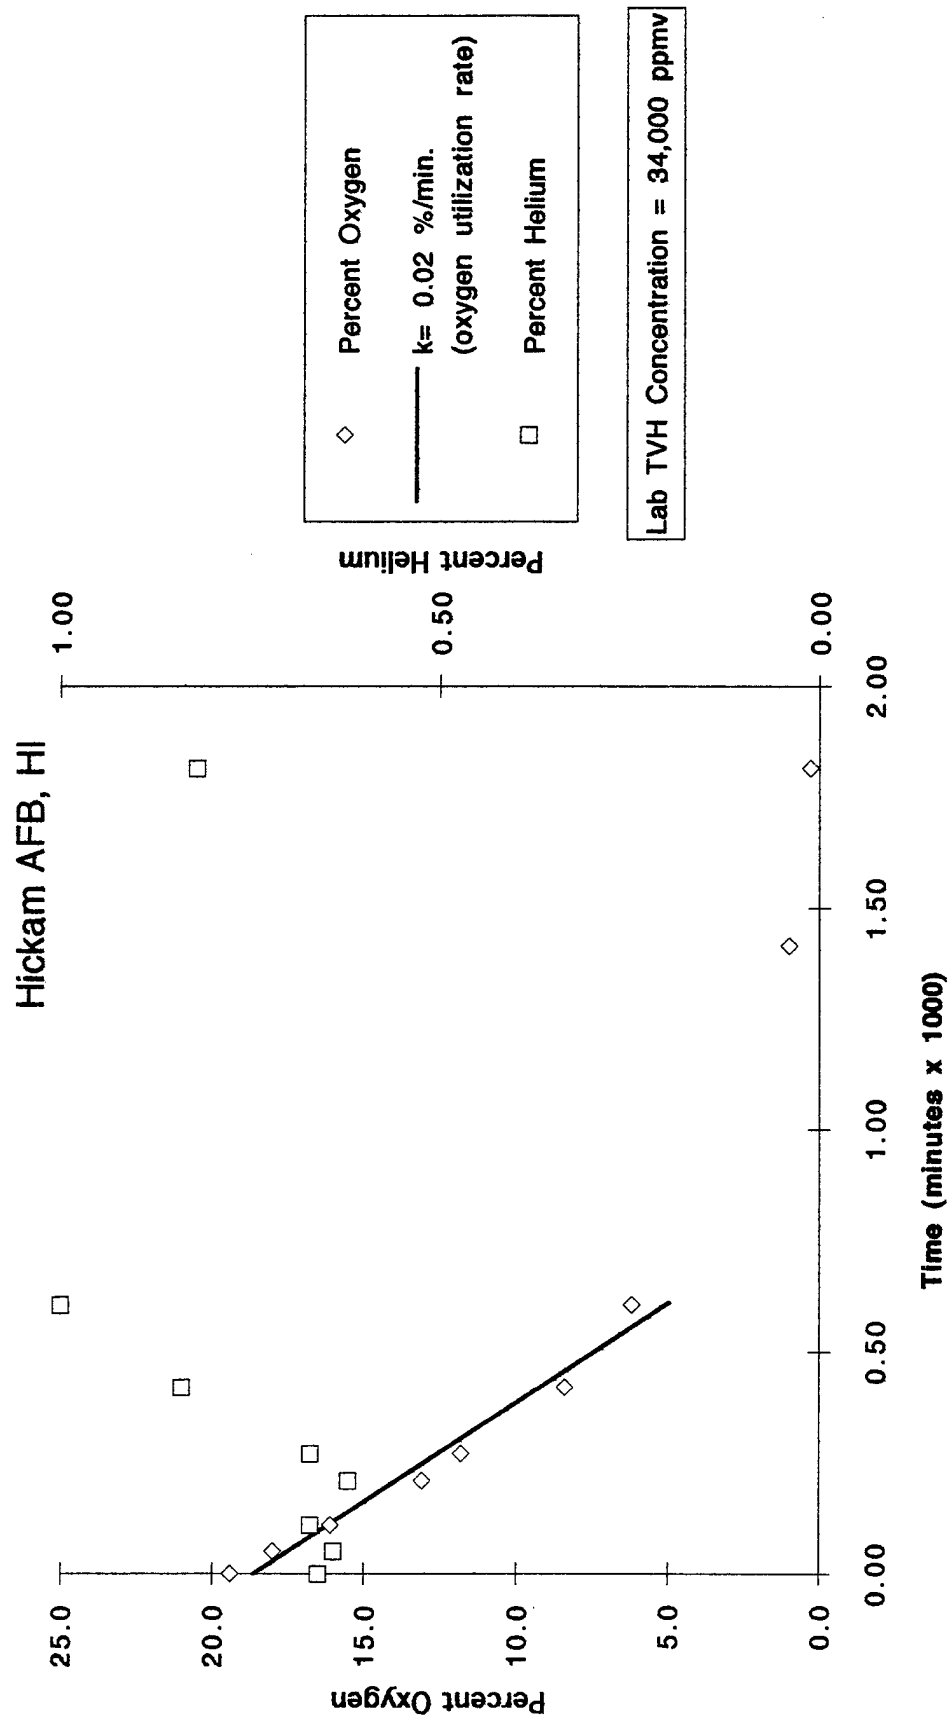
Figure 2.9
Respiration Test
Oxygen and Helium Concentrations
Area K
MPC
Hickam AFB, HI

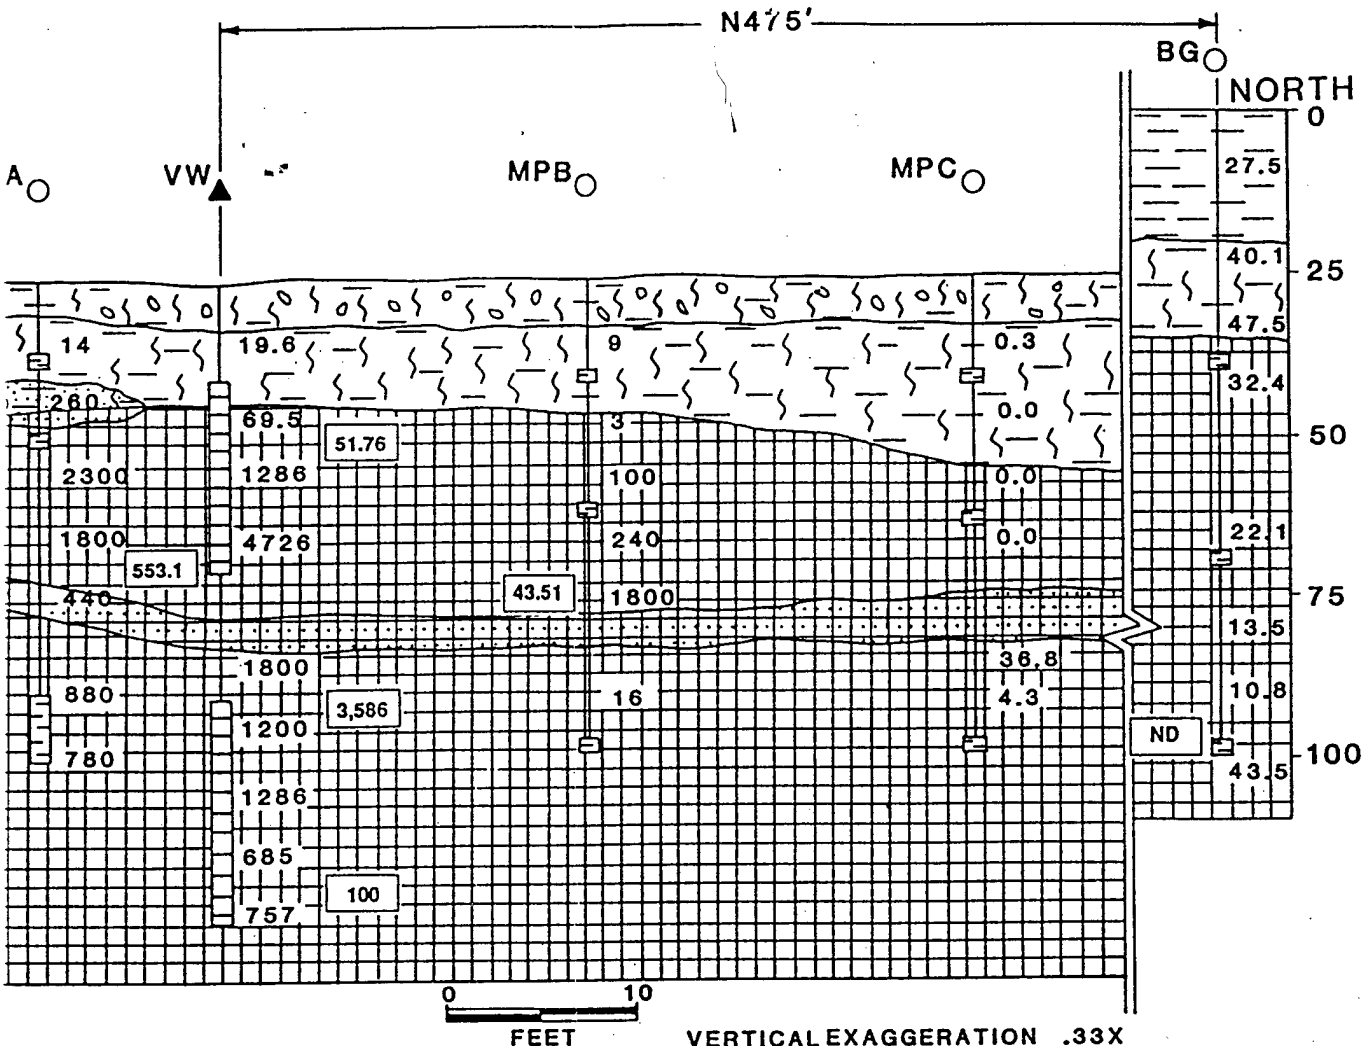
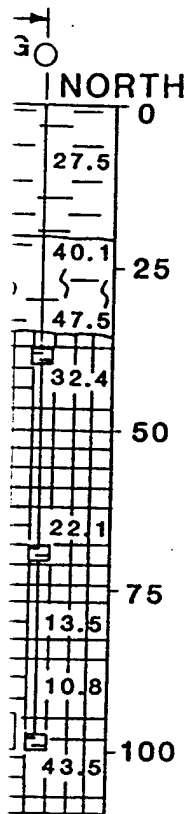
FIGURE 3.2

**SITE 2
HYDROGEOLOGIC
CROSS SECTION**

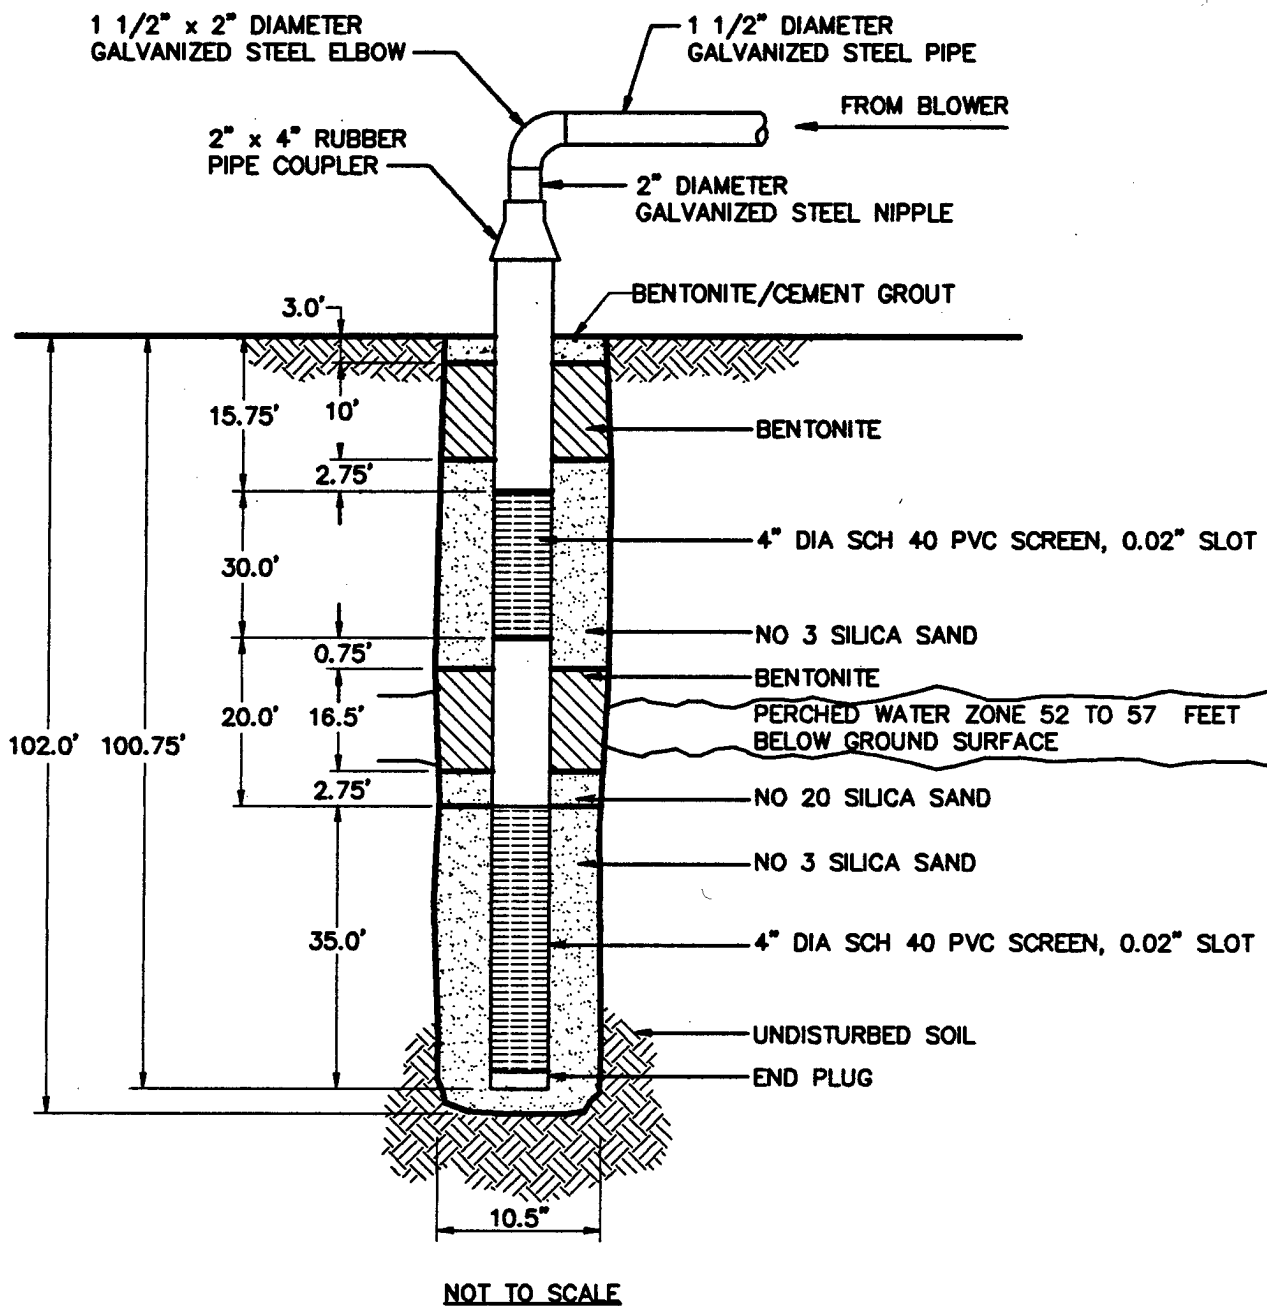
FIGURE 3.3

The air injection VW was installed following procedures described in the AFCEE bioventing protocol document (Hinchee et al., 1992). The VW was installed in soil that contained hydrocarbon contamination below 21 feet bgs. A zone of perched water was encountered at depths between 52 and 57 feet bgs. Figure 3.3 shows construction details for the VW.

The VW was constructed using 4-inch-diameter, Schedule 40 PVC casing with two intervals of 0.02-inch slotted screen. The shallow screen was installed from 15.75 to 45.75 feet bgs, and the deep screen was installed from 65.75 to 100.75 feet bgs. This two-screen configuration was required to prevent the perched water from entering the well casing, and to supply oxygen to unsaturated soils above and below the perched water zone. The annular space between the well casing and the borehole was filled with number 3 silica sand, bentonite, and bentonite/cement grout. Sand was placed from the bottom of the borehole to 63 feet bgs. From 46.5 to 63 feet bgs, bentonite slurry was placed to seal off the perched water zone. A second layer of sand was placed from 13 to 46.5 feet bgs. Granular bentonite was placed from 3 to 13 feet bgs to prevent injected air from short circuiting to the atmosphere. The granular bentonite was placed in 6-inch lifts, and each lift was hydrated in place using potable water. On top of the bentonite layer, approximately 3 feet of bentonite/cement grout was placed and finished flush with the ground.

SITE 2
AS-BUILT INJECTION VENT WELL
CONSTRUCTION DETAIL

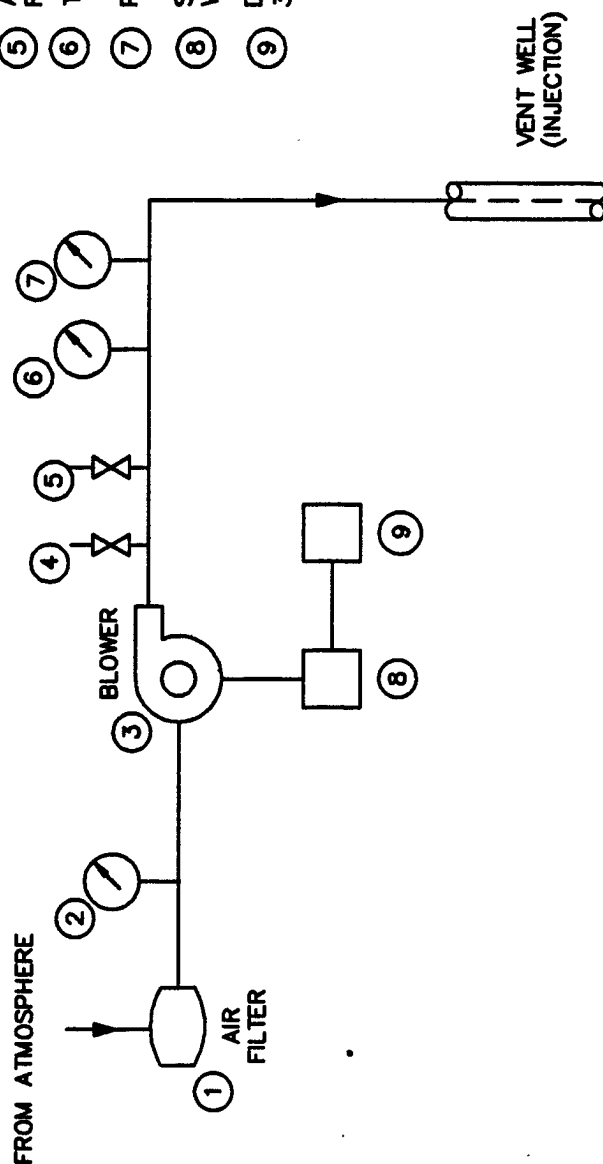
FIGURE 3.6

A 2.5-horsepower Gast® R5125Q-50 regenerative blower was used for both initial and extended pilot testing at Site 2. During the initial air permeability test, the unit was energized by 230-volt, single-phase, 30-amp power from a temporary exterior receptacle. The fixed unit is energized by 230-volt single-phase, 30-amp line power from a newly installed underground power line and aboveground breaker installed by base electricians. The configuration and instrumentation for this system are shown on Figure 3.6. The blower is currently transporting air at a flow rate of approximately 75 acfm for the extended pilot test. After blower installation and startup, ES engineers provided an O&M manual, including maintenance instructions, equipment specifications and monitoring forms, to base personnel. A copy of the O&M instructions is provided in Appendix A.

- ① INLET AIR FILTER - SOLBERG® AJ134E
- ② VACUUM GAUGE (0-60 in H₂O)
- ③ BLOWER - GAST® 2HP R5125Q-50
- ④ MANUAL PRESSURE RELIEF (BLEED) VALVE - 1 1/2" GATE
- ⑤ AUTOMATIC PRESSURE RELIEF VALVE, SET TO RELEASE AT 54 in H₂O PRESSURE
- ⑥ TEMPERATURE GAUGE (0-250 °F)
- ⑦ PRESSURE GAUGE (0-100 in H₂O)
- ⑧ STARTER - FURNAS® 14CSE32DA NEMA 3, WITH START/STOP, OVERLOAD SET AT 13AMPS
- ⑨ DISCONNECT SWITCH - 240V/SINGLE PHASE/30 AMP.

SITE 2 AS-BUILT BLOWER SYSTEM FOR AIR INJECTION

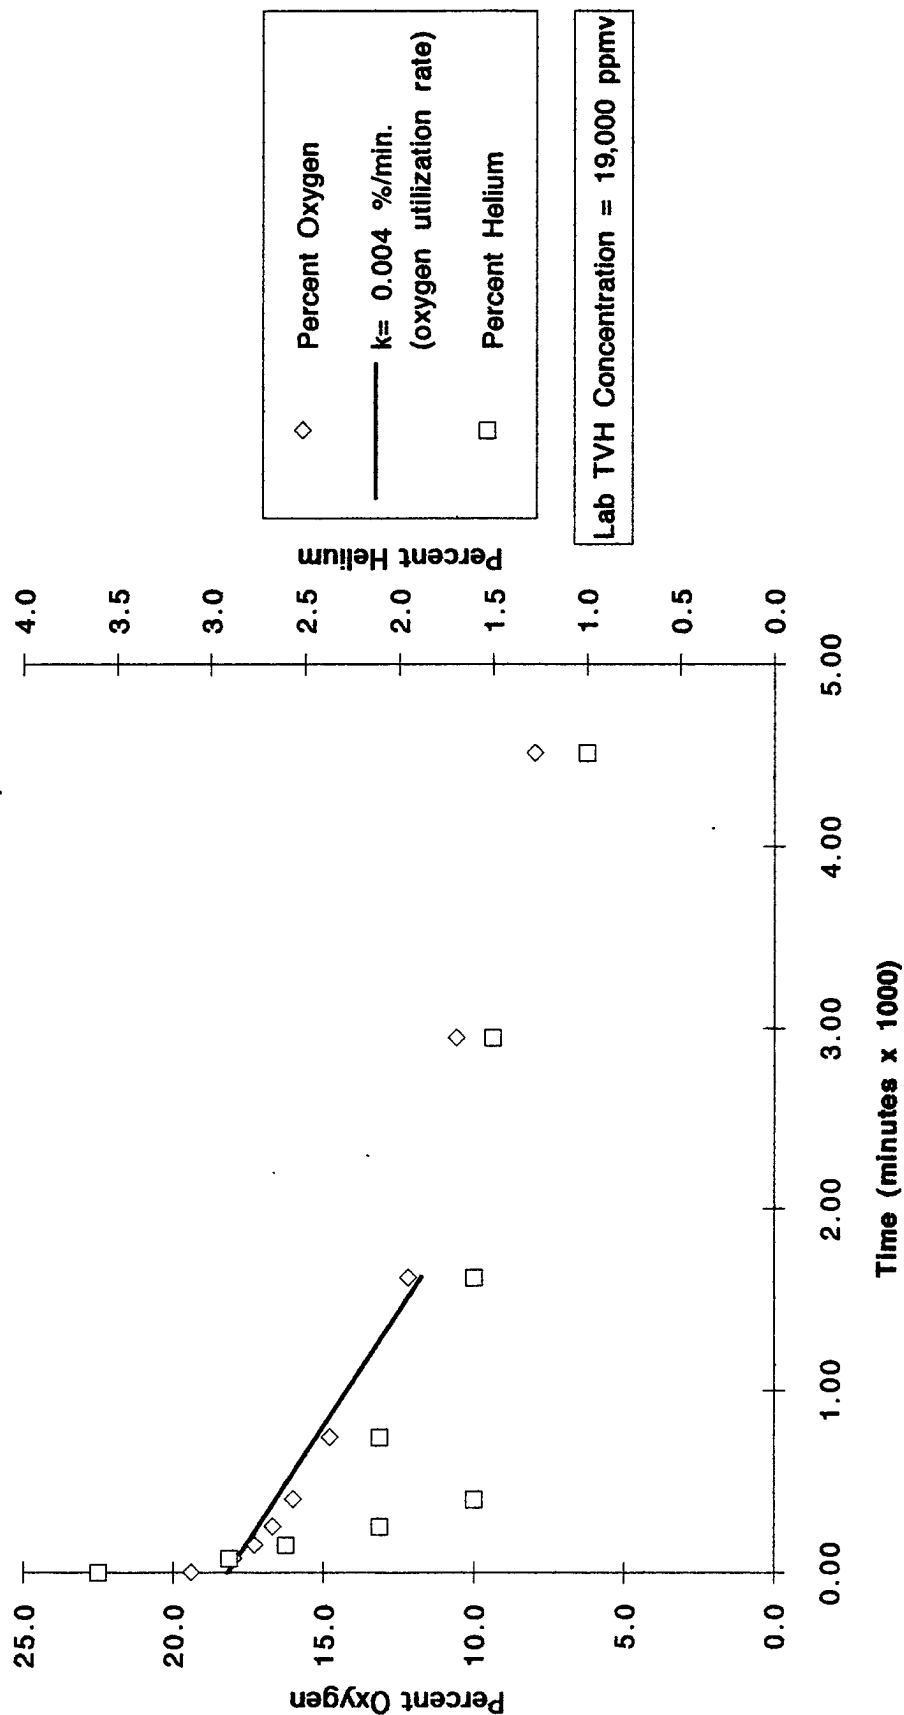
Figure 3.7
Respiration Test
Oxygen and Helium Concentrations
Site 2 - VW
Waikakalaua Fuel Storage Annex
Hickam AFB, HI

^{a/} Values based on linear regression (Figures 3.7 through 3.10).

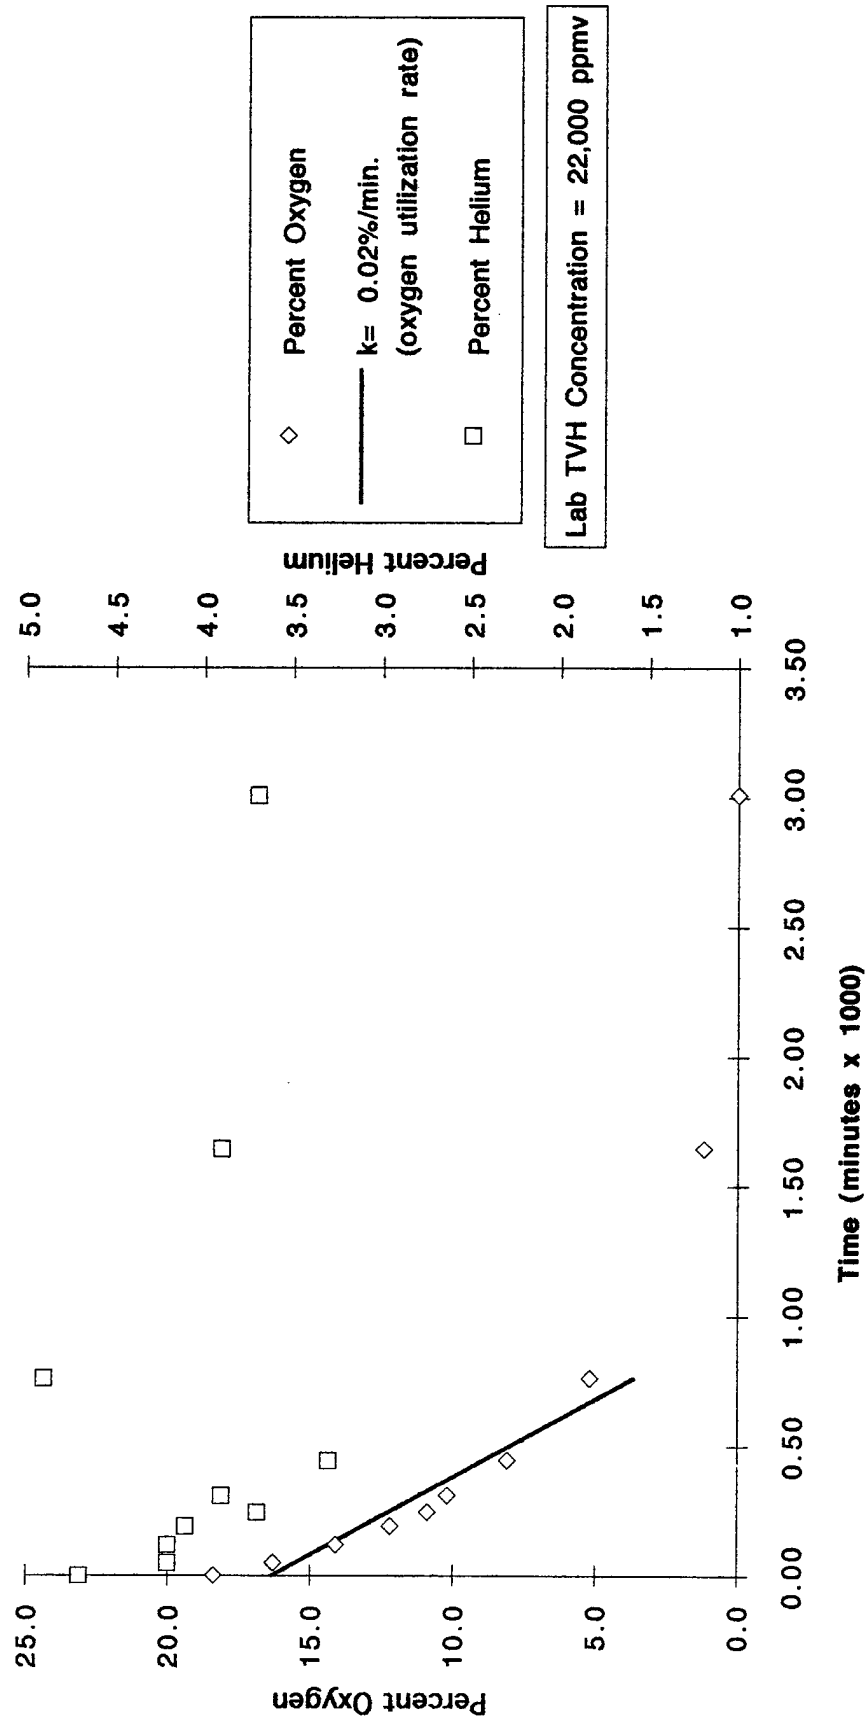
Figure 3.8
Respiration Test
Oxygen and Helium Concentrations
Site 2, MPA-24.3
Waikakalaua Fuel Storage Annex
Hickam AFB, HI

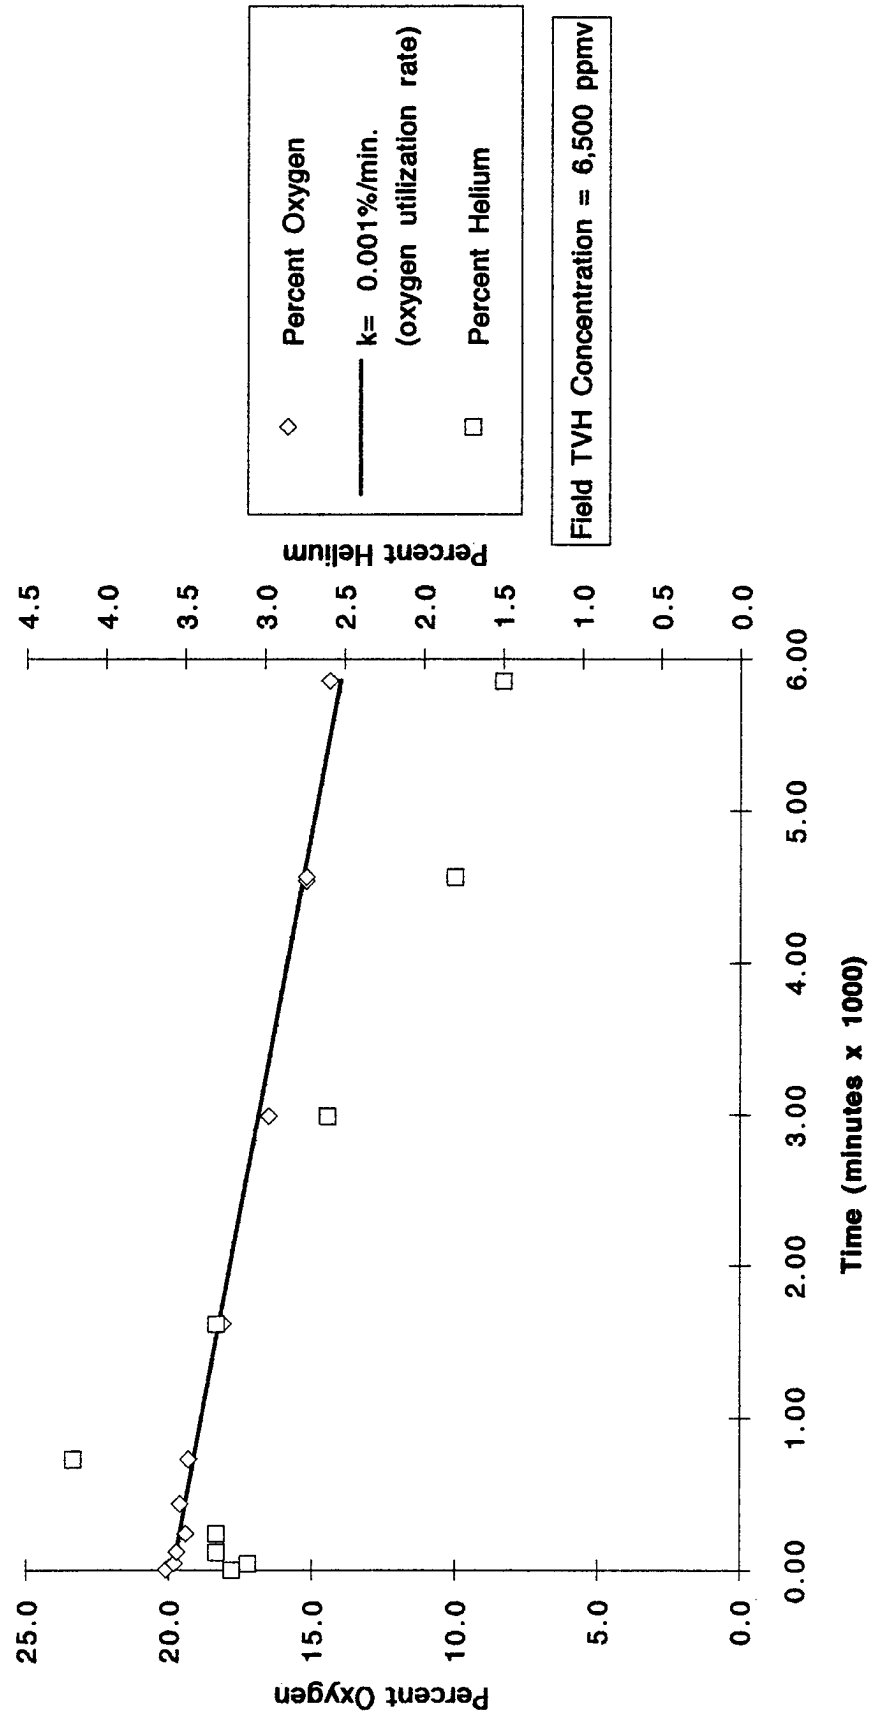
Figure 3.9
Respiration Test
Oxygen and Helium Concentrations
Site 2, MPB-36.1
Waikakalaua Fuel Storage Annex
Hickam AFB, HI

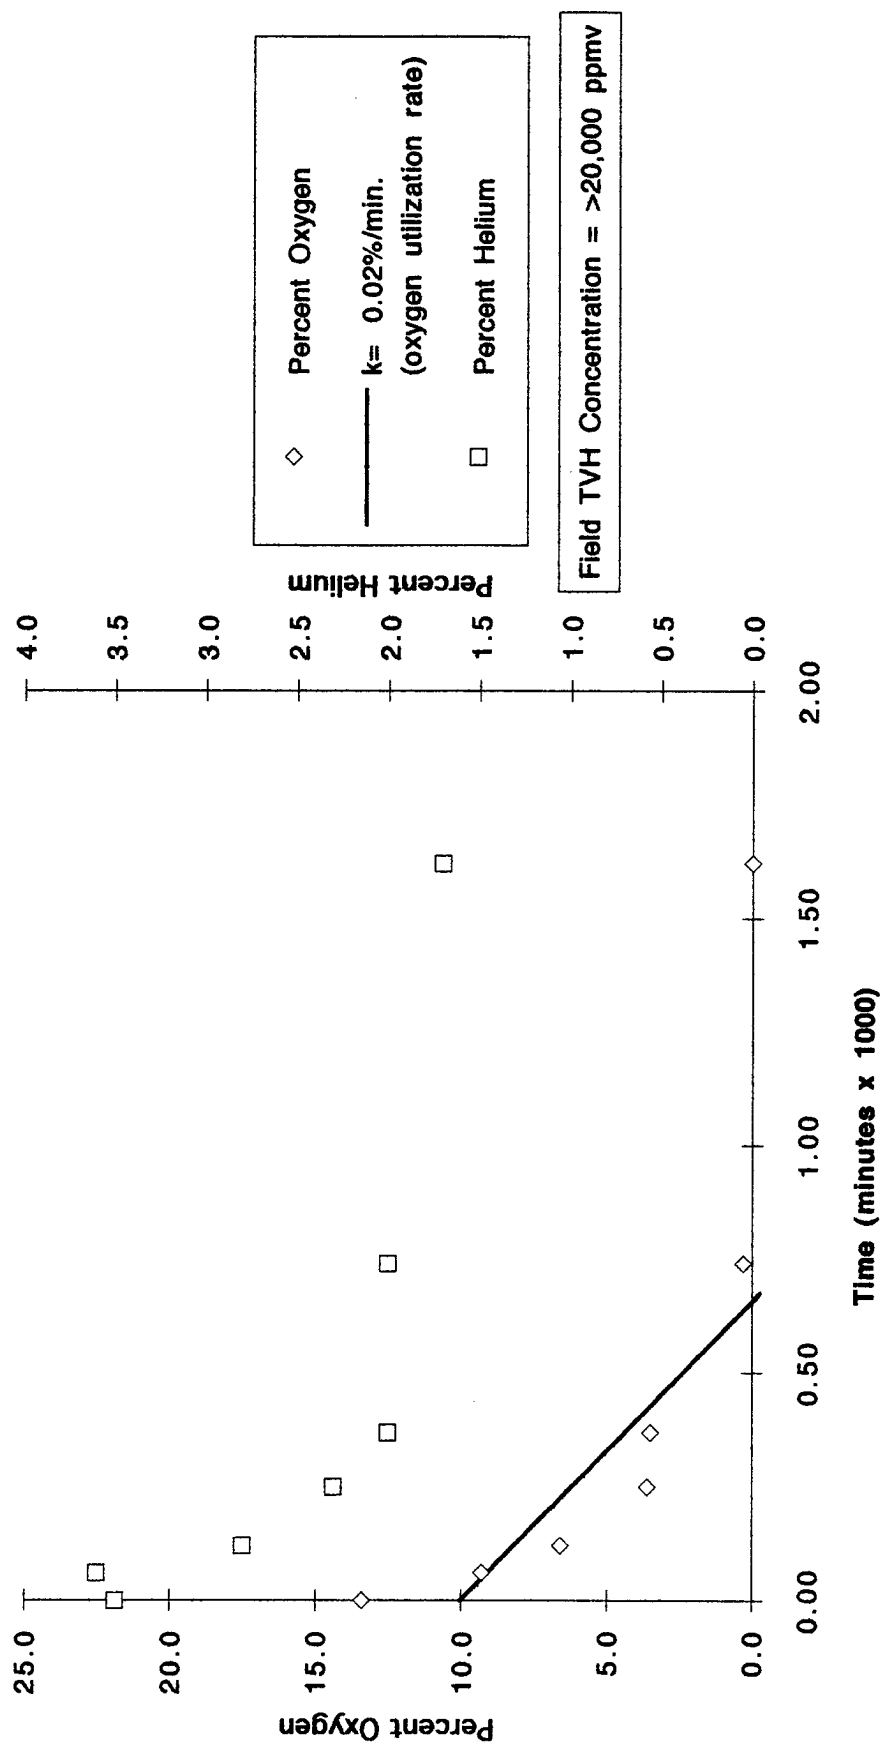
Figure 3.10
Respiration Test
Oxygen and Helium Concentrations
Site 2, MW-6
Waikakalaua Fuel Storage Annex
Hickam AFB, HI

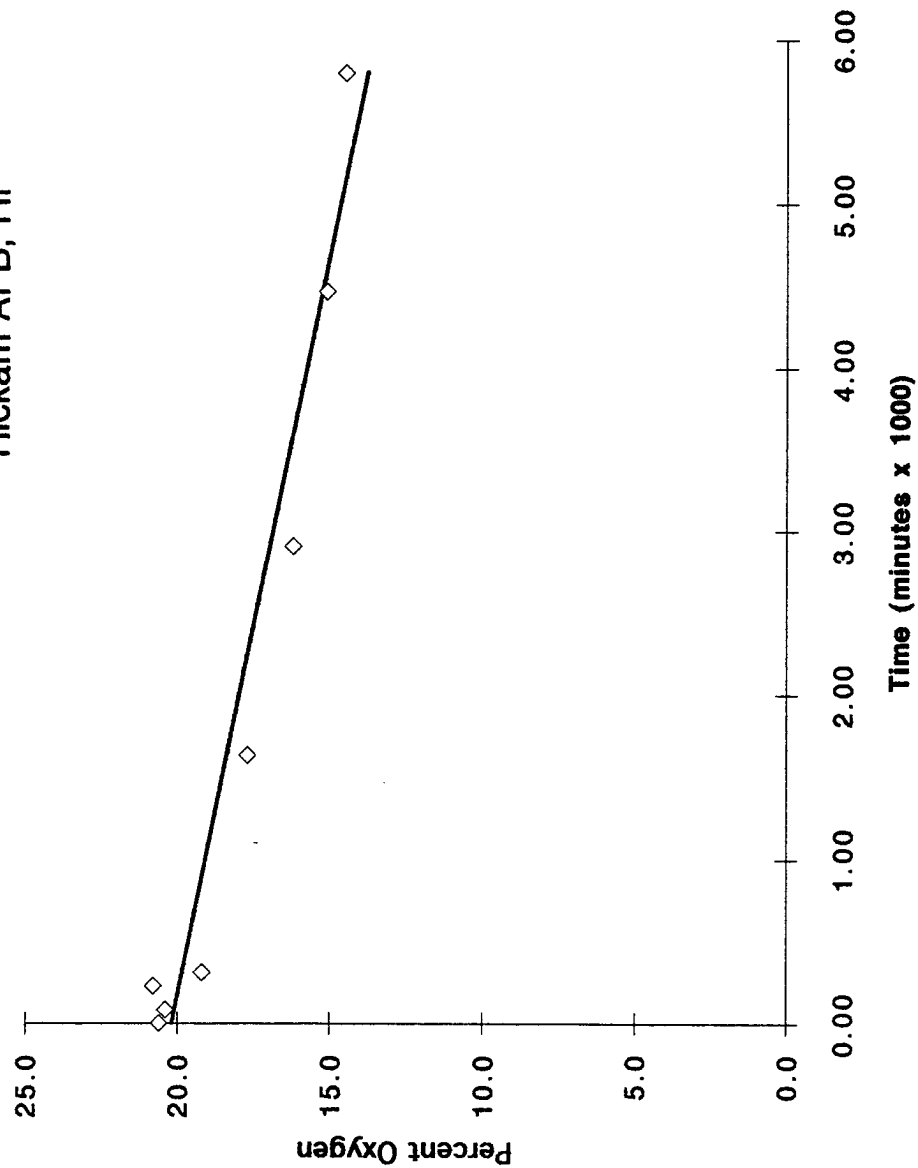
Figure 3.11
 Respiration Test
 Oxygen Concentrations
 Site 2, 2-BG-70.6
 Waikakalaua Fuel Storage Annex
 Hickam AFB, HI

— $k = 0.001\%/min.$
 (oxygen utilization rate)
